# Manhole Inspection Summary

Manhole # S21Y\_\_015MH

Insp Date: **5/18/08 2:37 PM**

**Location** Address: **2000 bremen st**

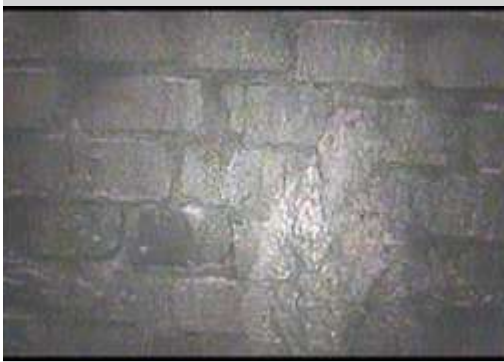
Defect 3

Infiltration: ☐ None ☐ Joint ☐ Cracks ☐ Mortar ☐ Roots ☒ **Wall**

infiltration & encrustation @ barrel wall

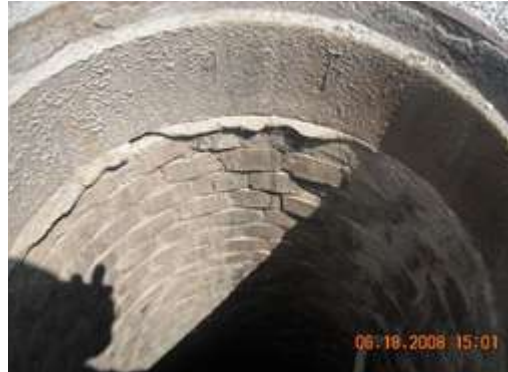
Defect 2

Subject To Ponding: **Sheeting**

inflow evidence from sheeting

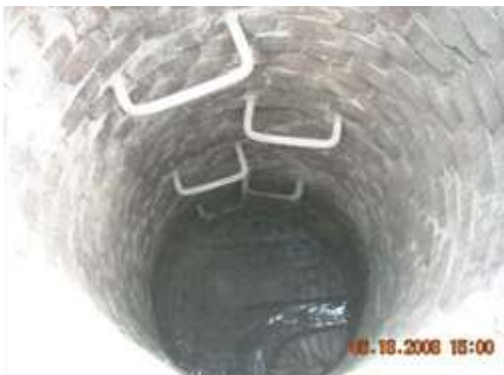
Defect 1

**Steps** Count: **6** Missing: **0** ☒ **Corroded**

corroded steps

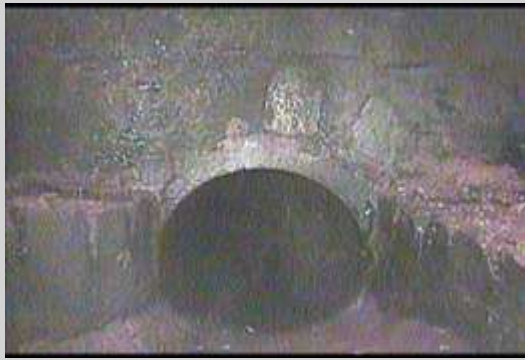
12 O'Clock Outflow

Pipe Height: **8.4** (in.) Rod and Bar (Angled)  
Pipe Material: **Clay** ☐ Pipe Lined  
Invert Depth: **11.70** (ft.) Flow Characteristics: **Slow**  
Deposits: ☒ None ☐ Mud ☐ Sludge ☐ Debris ☐ Grease  
Silt Depth: **0** (in.) Deposits Extent:  
Infiltration: **None** Pipe Seal Cond: **Sound**

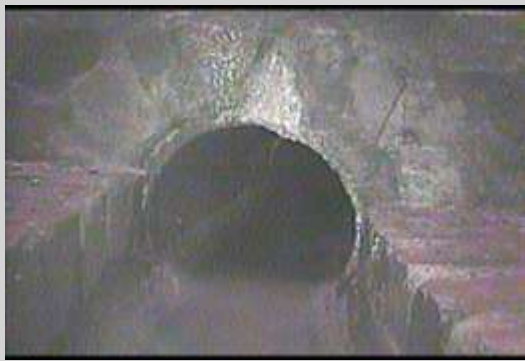
9 O'Clock Inflow

Pipe Height: **8.4** (in.) Rod and Bar (Angled)  
Pipe Material: **Clay** ☐ Pipe Lined  
Invert Depth: **11.35** (ft.) Flow Characteristics: **Slow**  
Deposits: ☒ None ☐ Mud ☐ Sludge ☐ Debris ☐ Grease  
Silt Depth: **0** (in.) Deposits Extent:  
Infiltration: **Evidence** Pipe Seal Cond: **Unknown**
